REMOVAL OF A FRACTURED INSTRUMENT FROM THE ROOT CANAL USING AN OPERATIVE MICROSCOPE – CASE REPORT

Case 1

Case 2

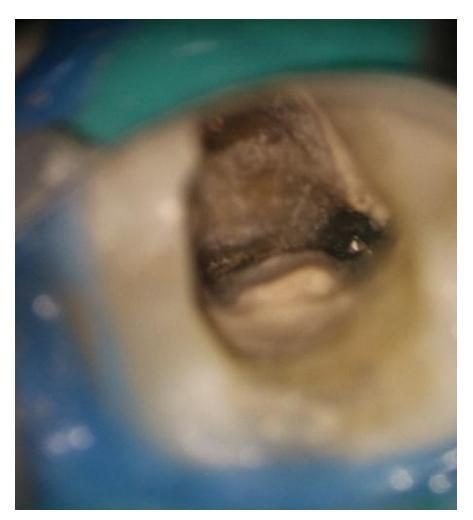
After obtaining informed consent, a rubber dam was placed, and the patient was positioned for treatment using a dental microscope (Zumax OMS2350 with six magnification levels -0.33x, 0.5x, 0.8x, 1.22x, 2x, and 3x). After removing the restoration, the root canal entry was widened using a Gates-Glidden Drill size 3 for better visualization of the coronal part of the instrument. Once the instrument was located (figure 1), ultrasonic tools (Dentsply Sirona Endo 1 and Endo 5) were used to carefully remove 2-3

Figure 1. Examination of the cavity of tooth 46 using an operative microscope, visualizing the fractured instrument under 2x magnification

mm of dentin apically around the instrument without excessive canal enlargement, using 1.22 x magnification. The ultrasonic tip was positioned around the instrument, first loosening it from the inner wall to facilitate removal. During the ultrasonic procedure, continuous irrigation with 5% NaOCl and 17% EDTA was performed to prevent overheating of the root. After each irrigation, an endodontic probe was used to assess the degree of instrument loosening. Once the instrument was sufficiently loosened, it was successfully extracted using a Loop from the Cerkamed Endo Removal System (figure 2).

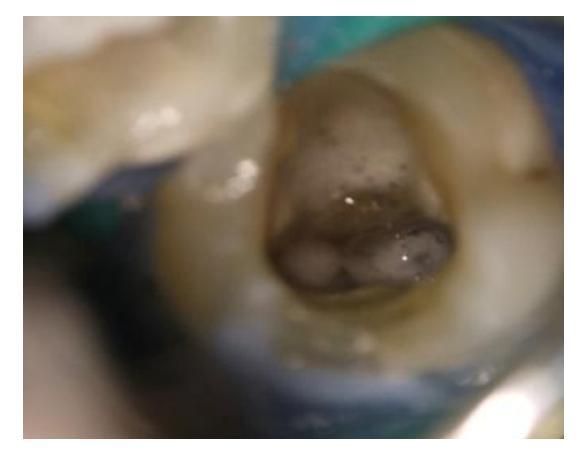
Figure 3. Visualization of activated 5% NaOCI under a microscope with 2x magnification.

- 1-minute activation of 5% NaOCl per canal (5ml),
- 1-minute activation of 17% EDTA per canal (5ml),
- 1-minute activation of 5% NaOCl per canal (5ml) (figure 3), followed by rinsing with distilled water (5 ml).

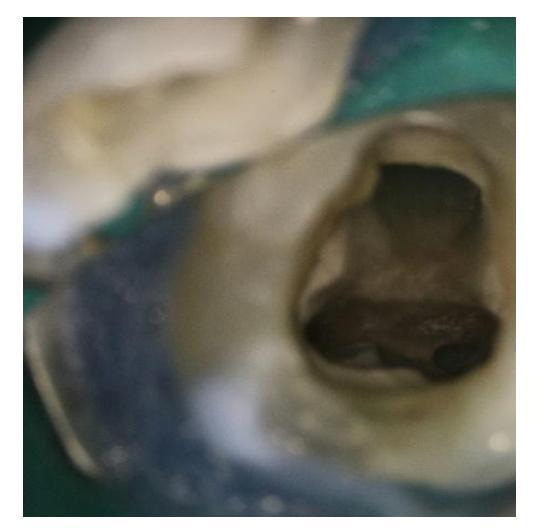
Figure 4. Examination of the cavity after the removal of the fractured instrument, showing the prepared three root canals under a microscope with 2x magnification.

After the final preparation of all three root canals (figure 4), they were dried with paper points (DiaDent) and definitively obturated with gutta-percha cones corresponding to the prepared sizes (distal canal with a 35/.04 gutta-percha cone, mesiobuccal canal with a 25/.04 cone, and mesiolingual canal with a 30/.04 cone – DiaDent), using AH Plus (Dentsply Sirona) as the sealer and applying the single cone technique (Figure 5).

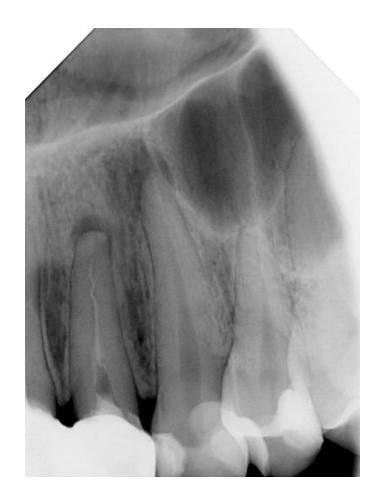
A 30-year-old female patient presented with pain in the maxillary left lateral incisor (tooth 22). A periapical radiograph (Figure 1a) revealed the presence of a fractured instrument in the root canal of the left lateral maxillary incisor, with a peri-apical lesion affecting the lateral incisor and the canine (teeth 22 and 23). Since the lateral incisor was also an abutment for a bridge construction, the intervention was performed through the crown with the aid of a dental microscope.

Figure 1. Radiograph of teeth 22 and 23 before the start of the intervention.

using an ultrasonic instrument (Dentsply Sirona Endo 1 and Endo 5). The working protocol was the same as in the previous case. Once the fractured instrument was successfully removed, final canal preparation was performed.

After determining the canal length with an apex locator (Woodpecker Woodpex III) and a K-file #10 (DiaDent), the canal was prepared using machine-driven expanders (Soco – SC Niti File) up to size 35/.04.

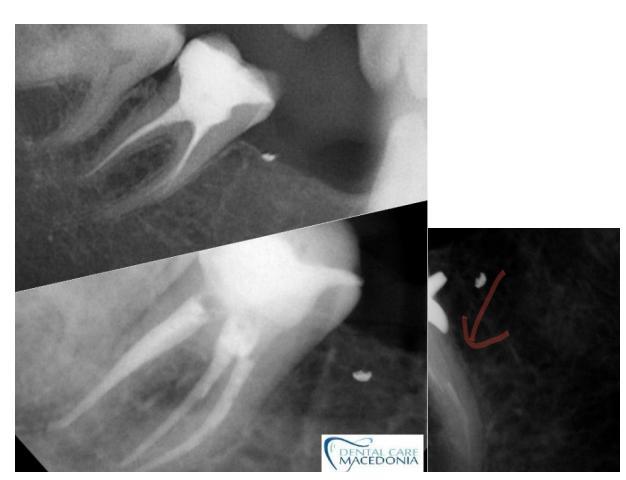
A 35-year-old patient presented with pain while chewing on the lower right molar (tooth 46). Intraoral examination revealed a large composite restoration with poor marginal adaptation. A periapical radiograph showed inadequate endodontic treatment and a fractured instrument in the mesiolingual canal.

Figure 5. Radiographic view of tooth 46 before and after the final obturation.

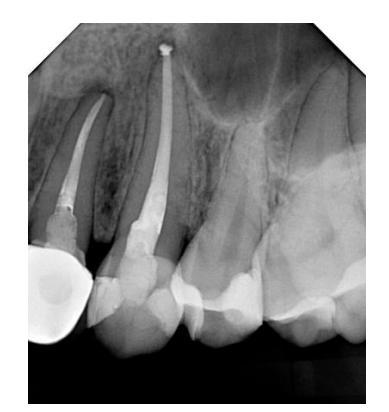
Figure 2. Radiograph of teeth 22 and 23 after 3 months.

After the canal preparation and cleaning, the system was dried with paper points (DiaDent 35/.04) and definitively obturated with gutta-percha cones (DiaDent 35/.04) and AH Plus (Dentsply Sirona) as a sealer using the single-cone technique (Figure 2).

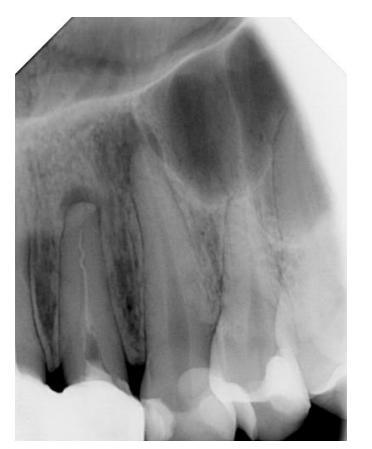
Figure 3. Radiograph of teeth 22 and 23 after 6 years.

In the second case, the instrument fracture was in the coronal third of the root canal, which led us to opt for its removal from the canal. The removal of the instrument enabled proper canal preparation, disinfection, and obturation, creating favorable conditions for adequate healing and repair of the surrounding periapical tissues.
